Inspection Report

Inspection location: Taicang, Jiangsu, China

Date of inspection: May 10, 2023

SGS order No.:		IN-SH-5801-23116			
Coordinator:				Telephone:	
Description of commodity					
Item No.	Description			Quantity	
1	WIRE ROPE,6x37+FC,Dia13mm,length1560mm				
Buyer					
Seller					
P/I No.	NA				
Others	NA				
Nature of inspection	Item	Satisfactory	Non conforming	Rejected	Subject to buyer's evaluation
	Quantity check	●			
	Visual quality check	●			
	Marking check	●			
	Dimension check	●			
	Witness the tensile test	●

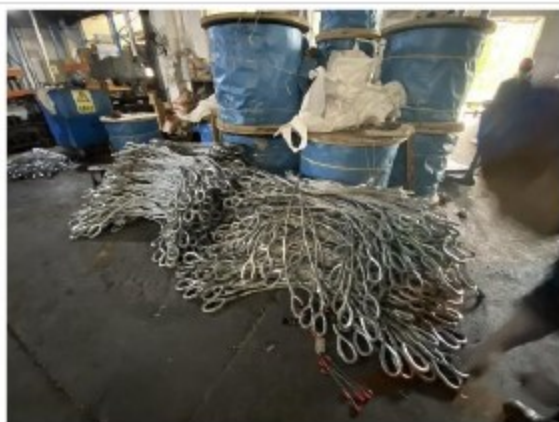
Visual quality check

The steel rope was brand new.

The steel wire was galvanized.

The surface was clean and smooth.
 No break, no deformation.
 No other obvious defect was found.
 The result is satisfactory.

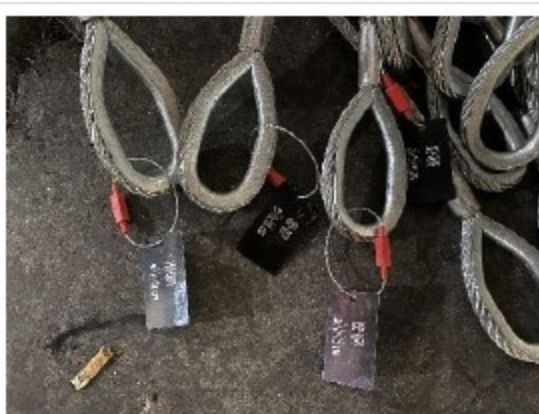
Mark check

A tag was found attached to the steel rope. The details were as following:

S83-0879

millsitd.cor

The mark was acceptable as per requirement from the client.

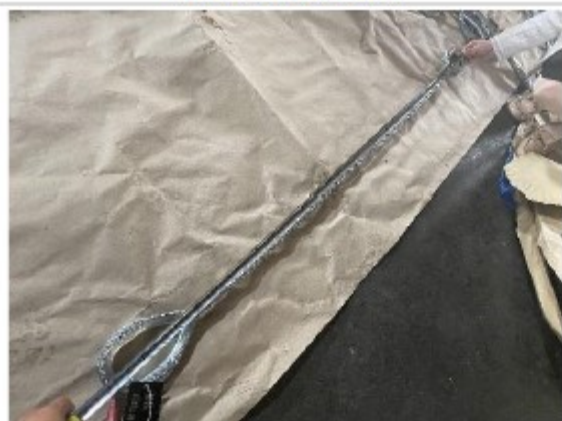
Dimension check

Dimension of the 10pcs steel rope were inspected. The details were as following:

No.	Description	Dia mm	Total length mm	Effective length mm	Result	Remark
1	WIRE ROPE,6x37+FC,Dia 13mm,length1560m m	13.12	1562	1512	Satisfactory	/
2		13.17	1562	1513	Satisfactory	/
3		13.11	1563	1513	Satisfactory	/
4		13.02	1561	1513	Satisfactory	/
5		13.04	1561	1512	Satisfactory	/
6		13.03	1563	1512	Satisfactory	/
7		13.04	1561	1511	Satisfactory	/
8		13.07	1563	1512	Satisfactory	/
9		13.11	1563	1512	Satisfactory	/
10		13.05	1563	1512	Satisfactory	/

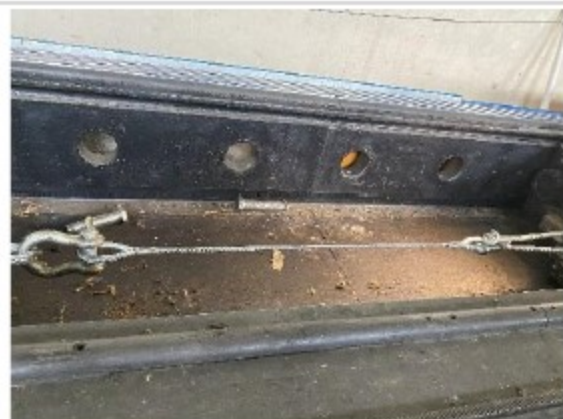
Tensile test

5 steel ropes were randomly selected and the tensile test was done. After holding time, the steel rope was tensiled break, the force was recorded.

No.	Description	Static load	Holding time	Break force	Result	Remark
1	WIRE ROPE, 6x37+FC, Dia 13mm, length 1560m m	2230kgf	3min	11630kgf	Satisfactory	/
2		2245kgf	3min	11550kgf	Satisfactory	/
3		2225kgf	3min	11590kgf	Satisfactory	/
4		2235kgf	3min	11620kgf	Satisfactory	/
5		2230kgf	3min	11600kgf	Satisfactory	/
